**M16C/63, 64A, 64C, 65, 65C, 6C, 5LD, 56D, 5L, 56,
5M, and 57 Groups**

R01AN1622EJ0120
 Rev. 1.20
 Dec.15, 2017

Troubleshooting for Serial Communications in Development

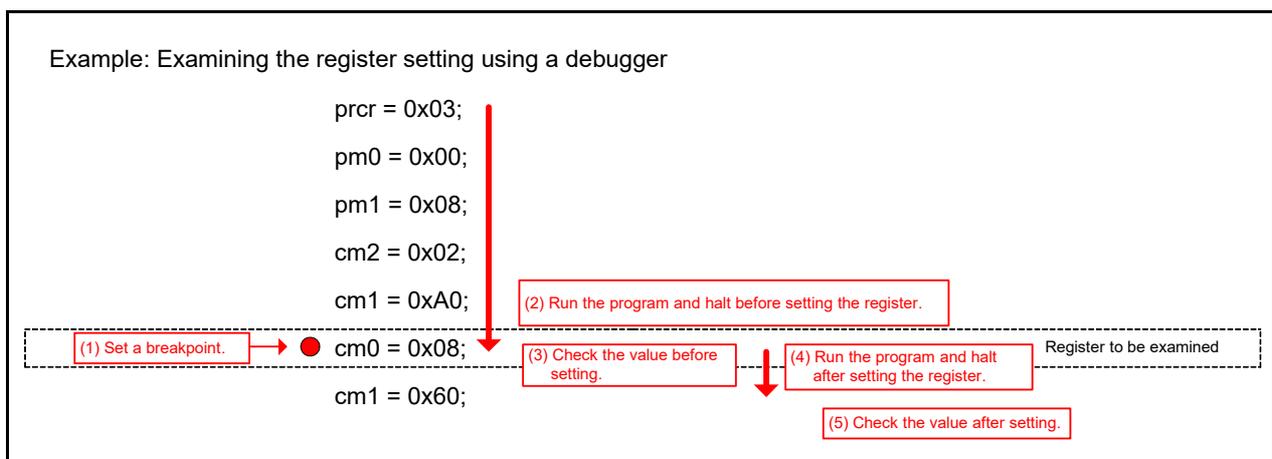
Figure 4.1 Examining the Register Setting Using a Debugger

With step (5) above, if the value is not set as expected, the register may be write protected or the specific setting procedure may have to be followed. Refer to the User's Manual: Hardware to confirm the condition for the register setting and its setting procedure.

Figure 4.1 shows the Examining the Register Setting Using a Debugger and Figure 4.2 shows Examining the Setting of the Register Protected by the PRC2 Bit.

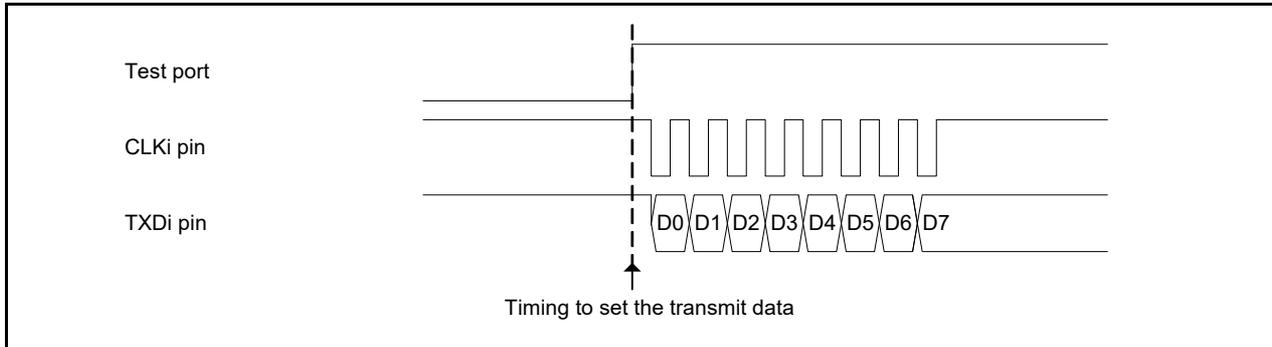
Figure 4.7 Signal pattern in a normal operation [A-1]

When the transmit data from the TXDi pin is as the data set in the UiTB register and the clock is output from the CLKi pin in an expected period, output signals are normal. Thus this is not the cause of the issue.

Make sure signals satisfy the operating conditions (rated values) in both communication devices.

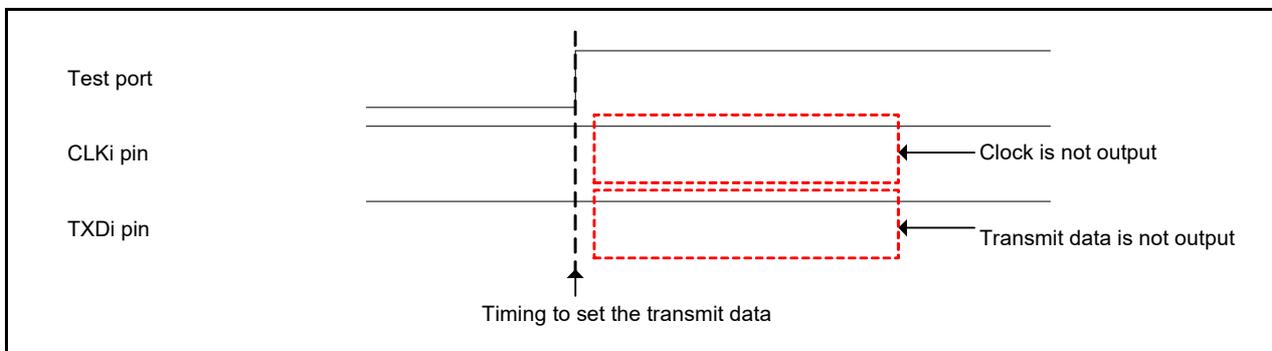
Figure 4.8 Signal pattern in an error operation [A-2]

Signals on the pins TXDi and CLKi remain high after a signal on the test port is inverted. In this case the transmit condition may not be met.

Check whether transmission is enabled (TE bit in the UiC1 register is 1) and the CTS function is enabled (bits CRS and CRD in the UiC0 register are 0). When the CTS function is used, also check if the CTSi pin is driven low.

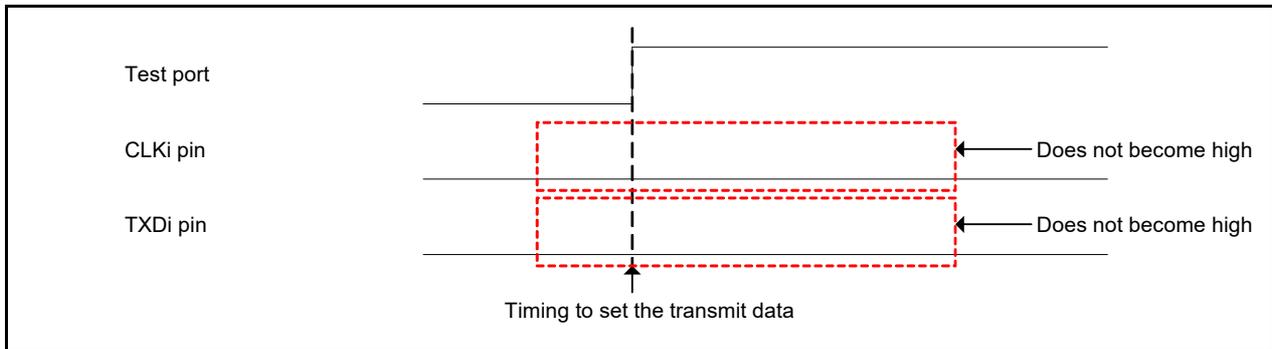
Figure 4.9 Signal pattern in an error operation [A-3]

Signals on pins TXDi and CLKi remain low after a signal on the test port is inverted. In this case the UiMR register may not be specified correctly (pins TXDi and CLKi are driven high when clock synchronous serial I/O mode is selected by the UiMR register), or possibly pins TXDi and CLKi are used as the N-channel open drain output pins and not pulled up.

Specify the UiMR register. If pins TXDi and CLKi are used as the N-channel open drain output pins, pull them up with an external circuit.

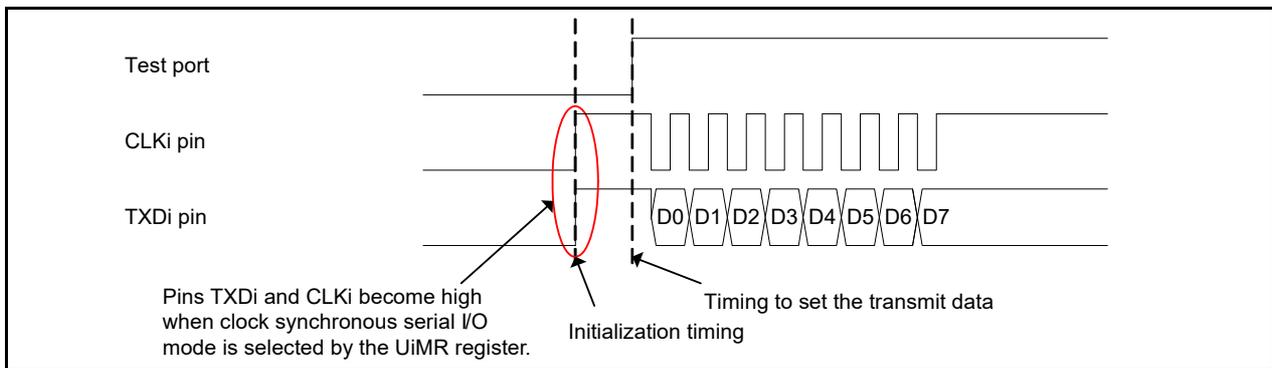
Figure 4.10 Signal pattern in an error operation [A-4]

Signals on pins TXDi and CLKi are driven low until a certain point. In this case these pins are driven low probably while the serial interface is disabled (until clock synchronous serial I/O mode is selected by the UiMR register). If the CLKi pin changes from low to high, the target device may recognize the change as the transmit/receive clock and bit slippage may occur.

Before the target device becomes ready for communication, set the UiMR register and drive the CLKi pin high, or pull up pins TXDi and CLKi with an external circuit, so that the pin levels do not change from low to high.

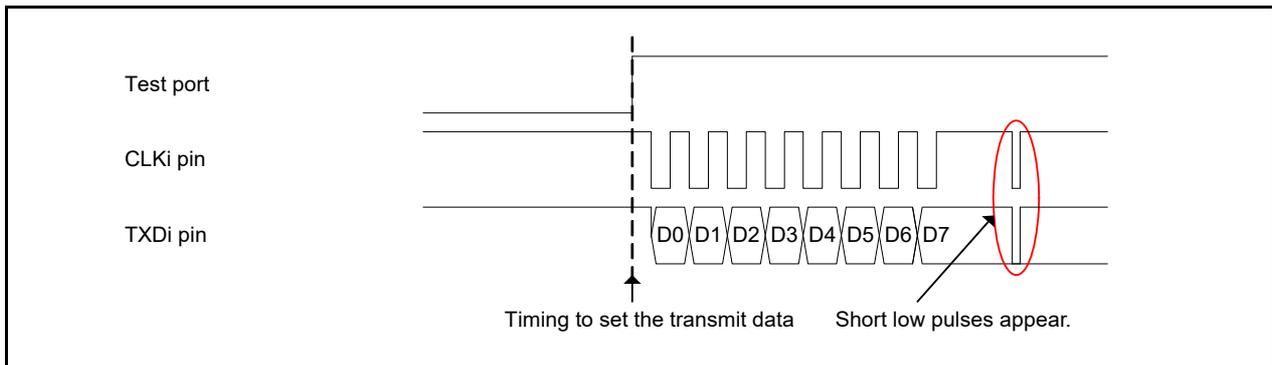
Figure 4.11 Signal pattern in an error operation [A-5]

Do not disable the serial interface every transmission. To avoid bit slippage, disable the serial interface when transmission is disabled in the target device or while the CLKi pin is pulled up.

When noise occurs, consider the design with less noise by adding a capacitor or moving the signal lines farther from the cause of the noise.

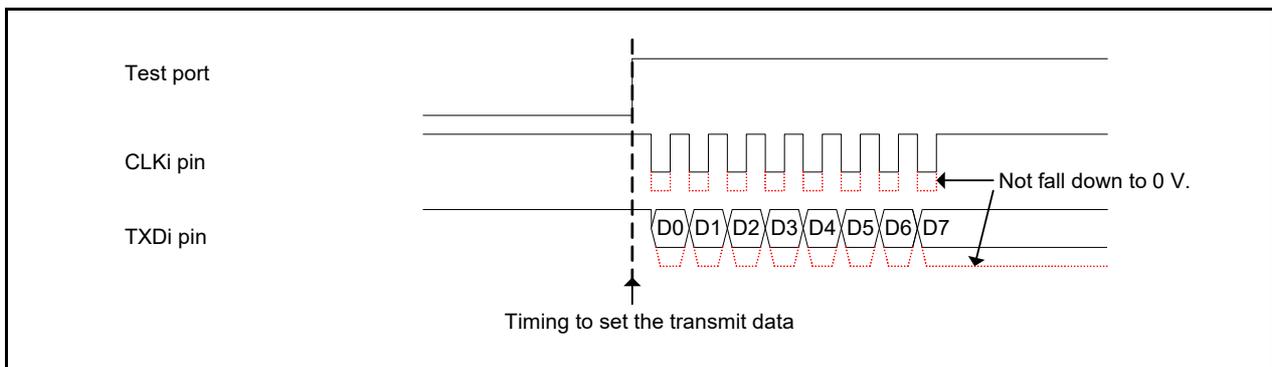
Figure 4.12 Signal pattern in an error operation [A-6]

Low level output from pins TXDi and CLKi does not fall down to 0 V or high level does not rise up to VCC. In this case other pins connected to pins TXDi and CLKi or the target device output signals and signal collision may occur. Or the operation conditions VIH or VIL in the target device are not satisfied and low and high levels may not be recognized correctly.

Examine the circuit and settings whether signals are output from pins connected to pins TXDi and CLKi or the target device.

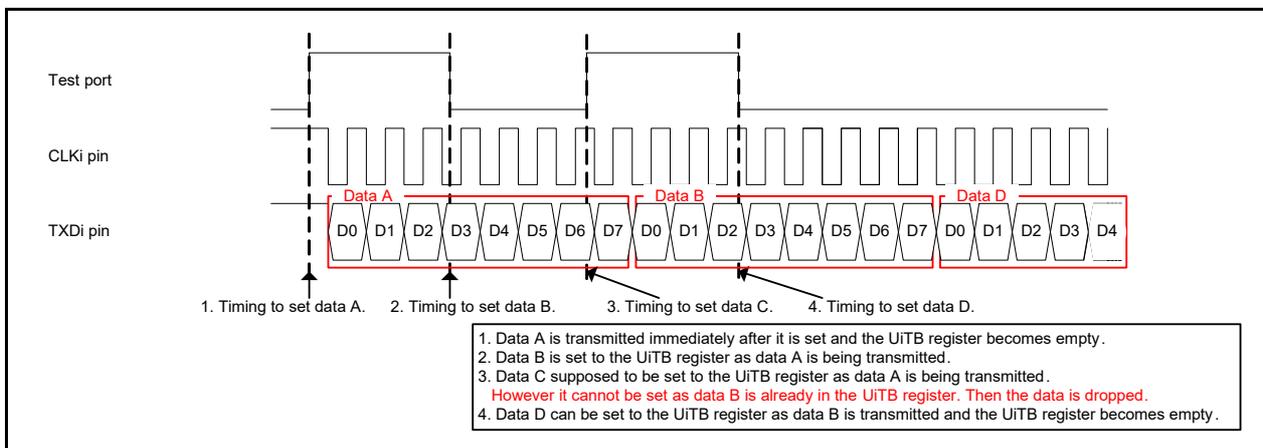
Figure 4.13 Signal pattern in an error operation [A-7]

The test port is inverted multiple times during 1-byte transmit data is output. In this case the next data is set to the UiTB register while the transmit buffer is full (TI bit in the UiC1 register is 0) and a data may be dropped.

First confirm the transmit buffer is empty or the transmission is completed, then set the next transmit data.

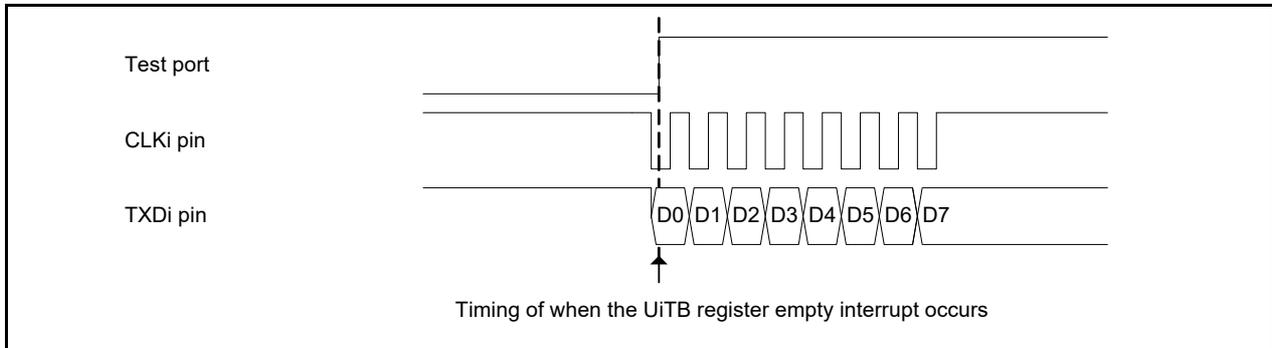
Figure 4.14 Signal pattern in a normal operation [B-1]

The test port is inverted on the first falling edge of the clock input to the CLKi pin. Transmit data is output from the TXDi pin synchronizing with the clock input to the CLKi pin.

When the transmit data from the TXDi pin is as the data set in the UiTB register and the clock is input to the CLKi pin in an expected period, I/O signals are normal. Thus this is not the cause of the issue. Make sure signals satisfy the operating conditions (rated values) in both communication devices.

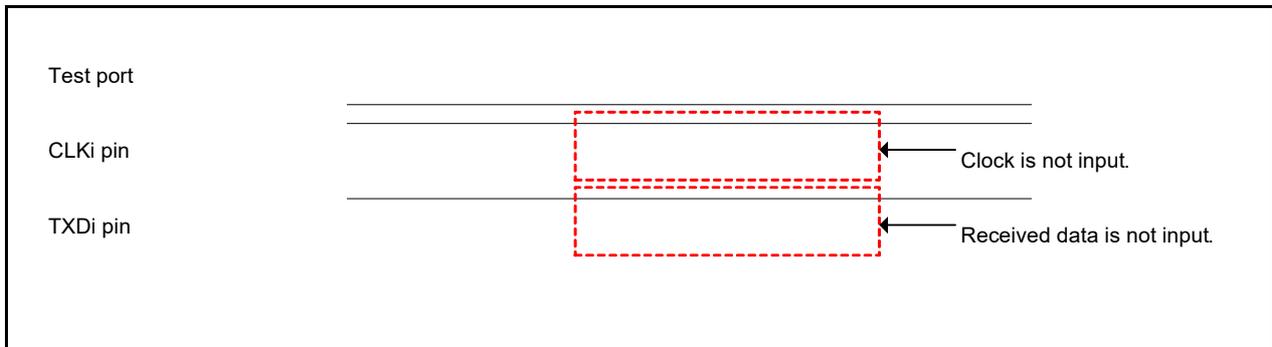
Figure 4.15 Signal pattern in an error operation [B-2]

A signal on the test port is not inverted. The clock is not input to the CLKi pin. In this case the target device is possibly not configured correctly and it may not operate. Check the settings in the target device.

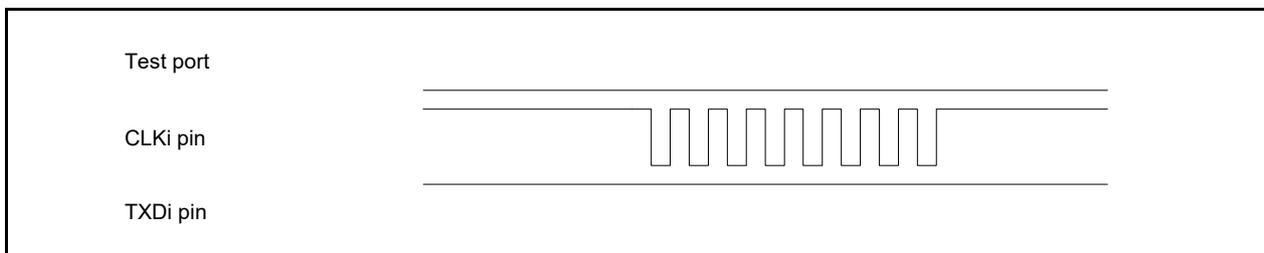
Figure 4.16 Signal pattern in an error operation [B-3]

The test port is not inverted. Transmit data is not output from the TXDi pin even though the clock is input to the CLKi pin. In this case the transmit condition may not be satisfied.

Check whether the transmission is enabled (TE bit in the UiC1 register is 1). Also check whether the CTS function is enabled (bits CRS and CRD in the UiC0 register are 0). When the CTS function is used, check whether the CTSi pin is driven low.

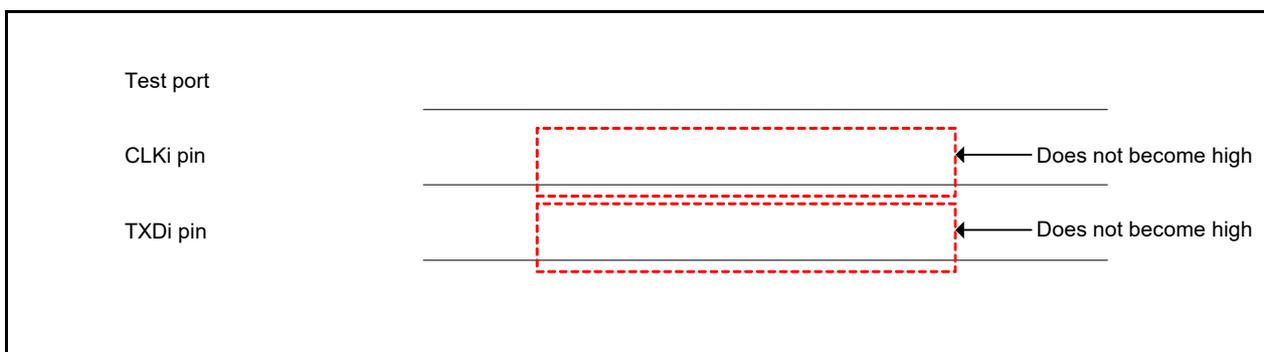
Figure 4.17 Signal pattern in an error operation [B-4]

Signals on the test port, TXDi pin, and CLKi pin remain low. In this case the UiMR register may not be specified correctly (pins TXDi and CLKi are driven high when clock synchronous serial I/O mode is selected by the UiMR register), or possibly pins TXDi and CLKi are used as N-channel open drain output pins and not pulled up.

Specify the UiMR register. If pins TXDi and CLKi are used as N-channel open drain output pins, pull them up with an external circuit.

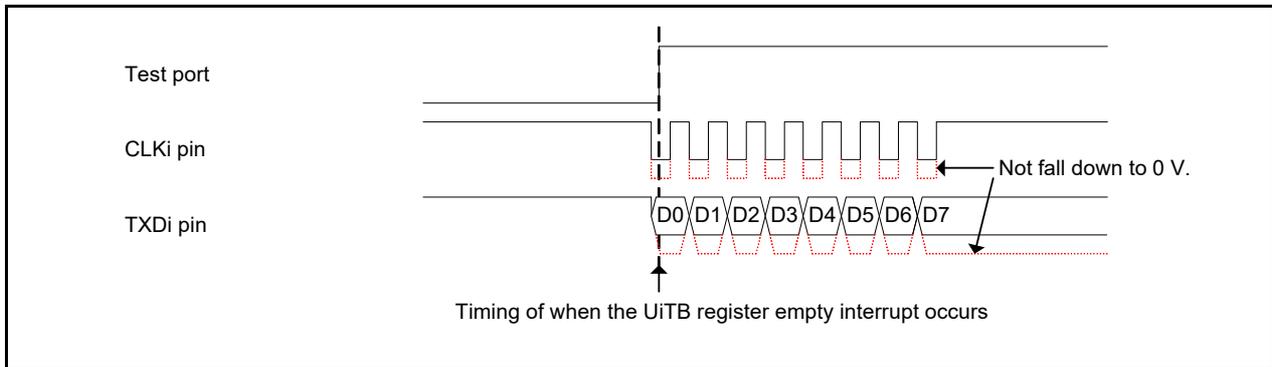
Figure 4.18 Signal pattern in an error operation [B-5]

Low level output from the TXDi pin and input to the CLKi pin does not fall down to 0 V or high level does not rise up to VCC. In this case other pins connected to pins TXDi and CLKi or the target device may output signals and signal collision may occur. Or the operation conditions VIH or VIL in the target device are not satisfied and low and high levels may not be recognized correctly.

Examine the circuit and settings whether signals are output from pins connected to pins TXDi and CLKi or the target device.

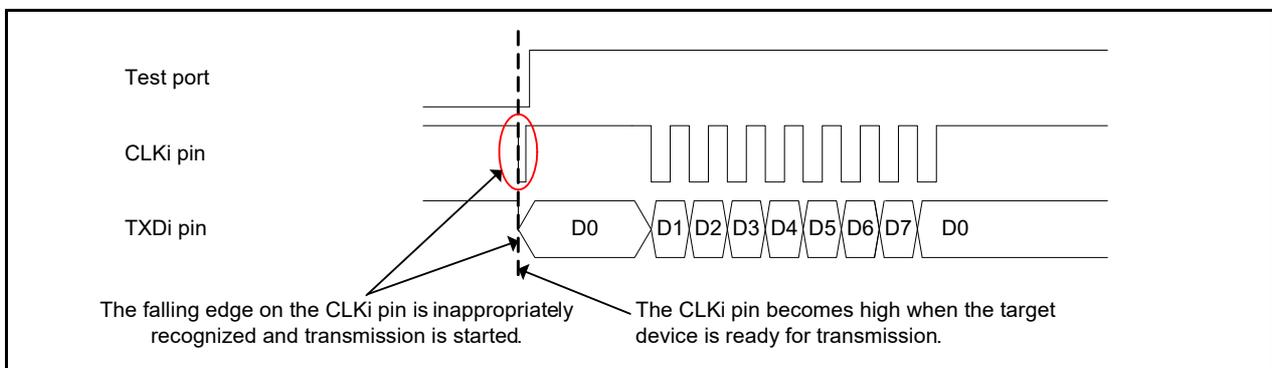
Figure 4.19 Signal pattern in an error operation [B-6]

Short low pulses appear on pins TXDi and CLKi. In this case noise may be introduced from peripheral circuits or external sources. If a pulse appears on the CLKi pin, bit slippage may occur in the target device.

Do not disable the serial interface every transmission. To avoid bit slippage, disable the serial interface when transmission is disabled in the target device or while the CLKi pin is pulled up.

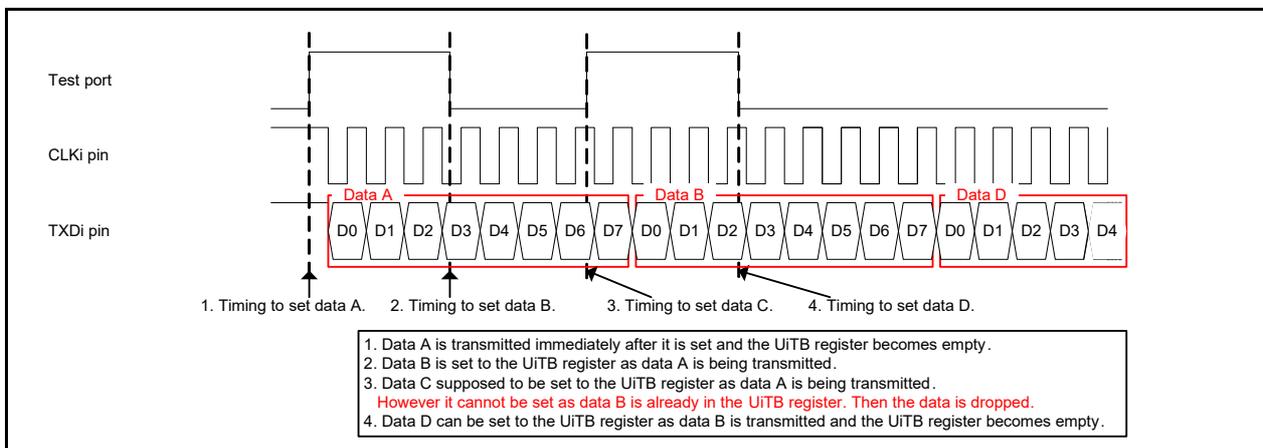
Figure 4.20 Signal pattern in an error operation [B-7]

The test port is inverted multiple times during 1-byte transmit data is output. In this case the next data is set to the UiTB register while the transmit buffer is full (TI bit in the UiC1 register is 0) and a transmit data may be dropped.

When setting the next transmit data, make sure the transmit buffer is empty or the transmission is completed.

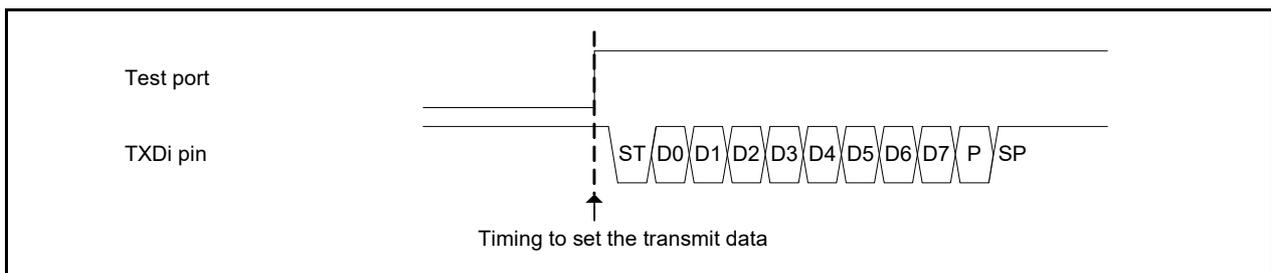
Figure 4.21 Signal pattern in a normal operation [C-1]

Transmit data is output from the TXDi pin immediately after a signal on the test port is inverted. When the transmit data from the TXDi pin is as the data set in the UiTB register, the output signal is normal. Thus this is not the cause of the issue. Make sure signals satisfy the operating conditions (rated values) in both communication devices.

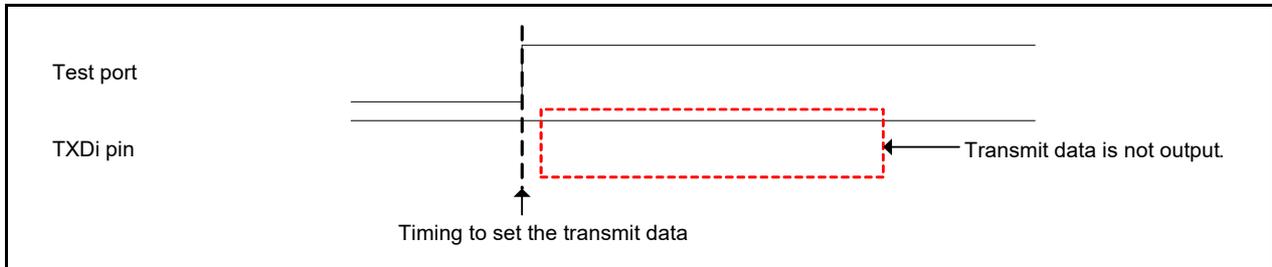
Figure 4.22 Signal pattern in an error operation [C-2]

Signals on the TXDi pin remain high after a signal on the test port is inverted. In this case the transmit condition may not be satisfied.

Check whether transmission is enabled (TE bit in the UiC1 register is 1) and the CTS function is enabled (bits CRS and CRD in the UiC0 register are 0). When the CTS function is used, also check if the CTSi pin is driven low.

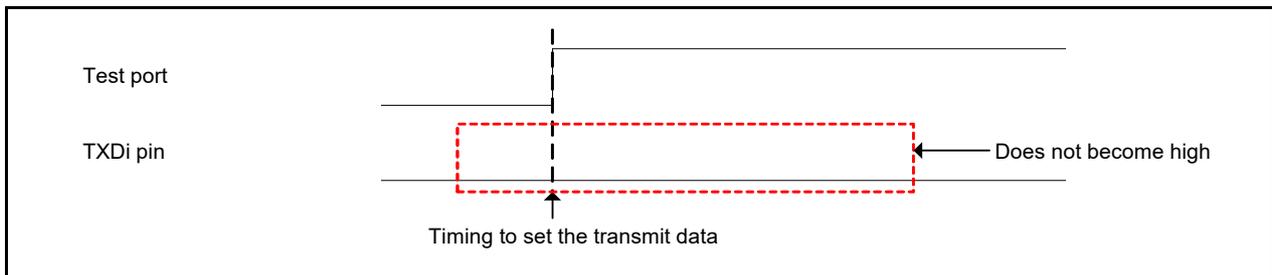
Figure 4.23 Signal pattern in an error operation [C-3]

Signals on the TXDi pin remain low after a signal on the test port is inverted. In this case the UiMR register may not be specified correctly (TXDi pin is driven high when UART mode is selected by the UiMR register), or possibly the pin is used as the N-channel open drain output pin and not pulled up.

Specify the UiMR register. If the TXDi pin is used as the N-channel open drain output pin, pull it up with an external circuit.

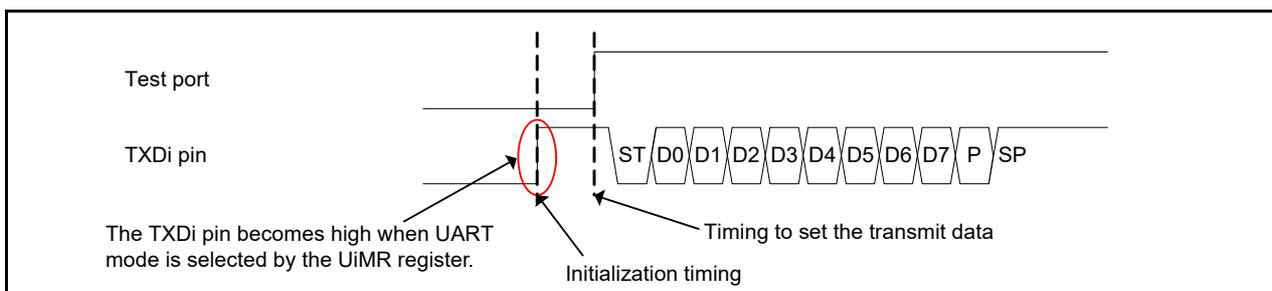
Figure 4.24 Signal pattern in an error operation [C-4]

The TXDi pin is driven low until a certain point. In this case the pin is driven low probably while the serial interface is disabled (until UART mode is selected by the UiMR register). The target device may inappropriately recognize the start bit, and incorrect data may be received.

Before the target device becomes ready for communication, set the UiMR register and drive the TXDi pin high, or pull up the TXDi pin with an external circuit, so that the pin is not driven low.

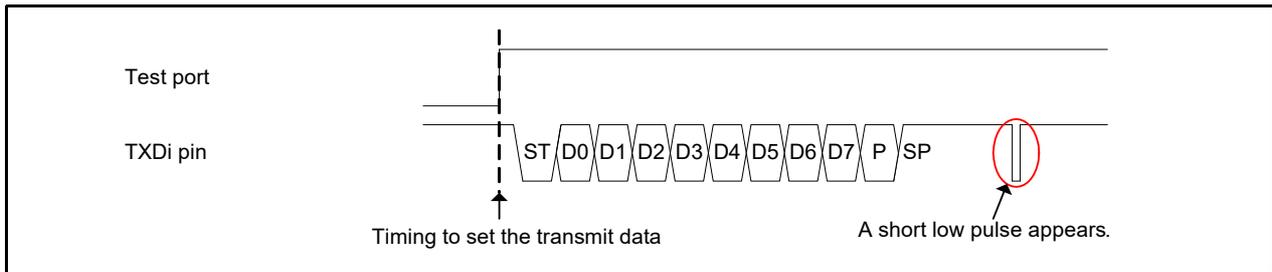
Figure 4.25 Signal pattern in an error operation [C-5]

Do not disable the serial interface every transmission. Disable the serial interface when reception is disabled in the target device or while the TXDi pin is pulled up so that the target device can receive correct data.

When noise occurs, consider the design with less noise by adding a capacitor or moving the signal lines farther from the cause of the noise.

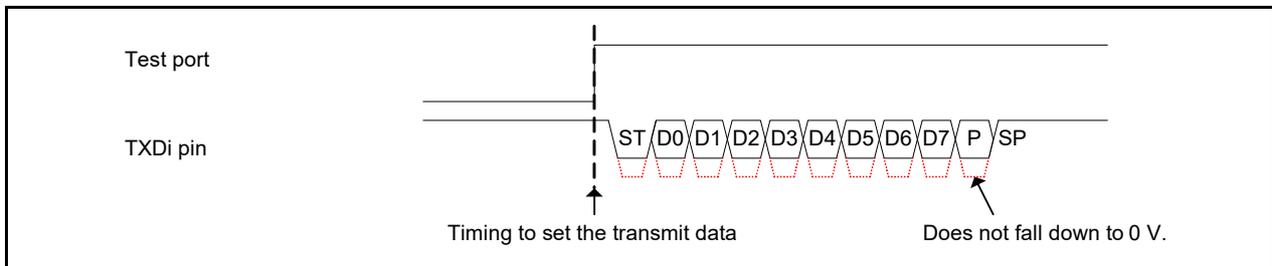
Figure 4.26 Signal pattern in an error operation [C-6]

Low level output from the TXDi pin does not fall down to 0 V or high level does not rise up to VCC. In this case other pins connected to the TXDi pin or the target device may output signals and signal collision may occur. Or the operation conditions for VIH or VIL in the target device are not satisfied and low and high levels may not be recognized correctly.

Examine the circuit and settings whether signals are output from pins connected to the TXDi pin or the target device.

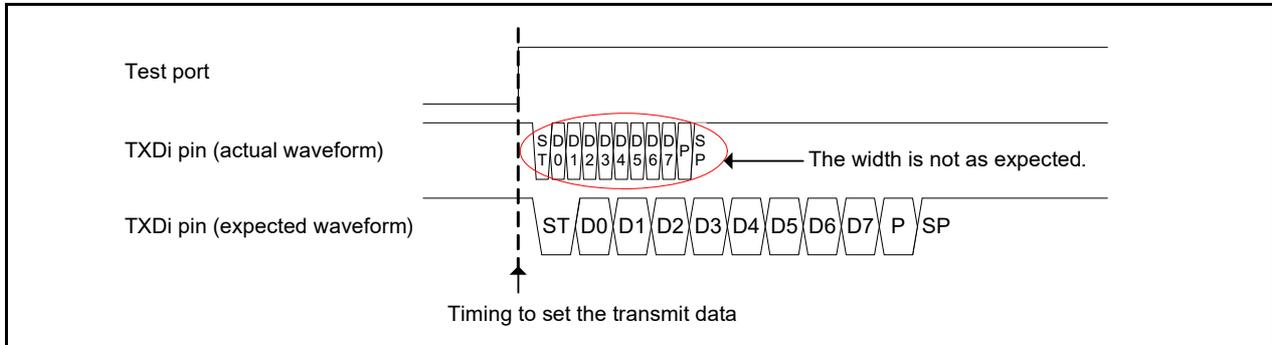
Figure 4.27 Signal pattern in an error operation [C-7]

Width of a signal output from the TXDi pin for each bit is shorter or longer than the width expected. In this case the bit rate may not be specified correctly.

Check whether the setting for the UiBRG register, the CPU clock, or the count source is correctly specified.

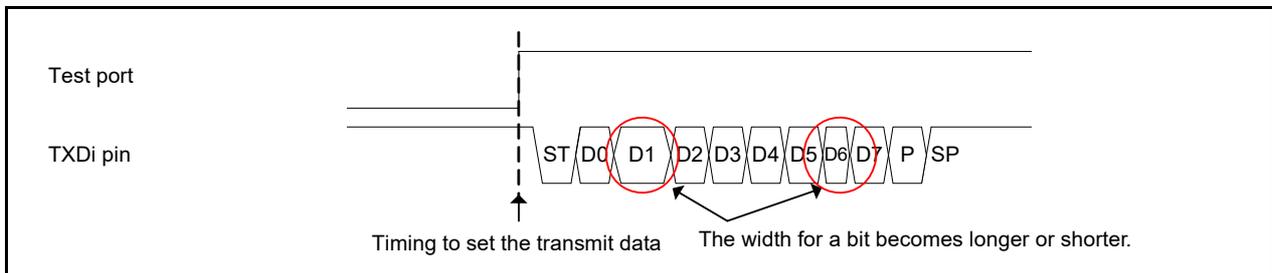
Figure 4.28 Signal pattern in an error operation [C-8]

Width of a signal output from the TXDi pin for a bit is shorter or longer than the width expected. In this case the UiBRG register may be refreshed or rewritten. If the register is refreshed or rewritten during transmission, the bit rate may not be held internally and data cannot be transmitted or received correctly.

Do not refresh or rewrite the UiBRG register during transmission.

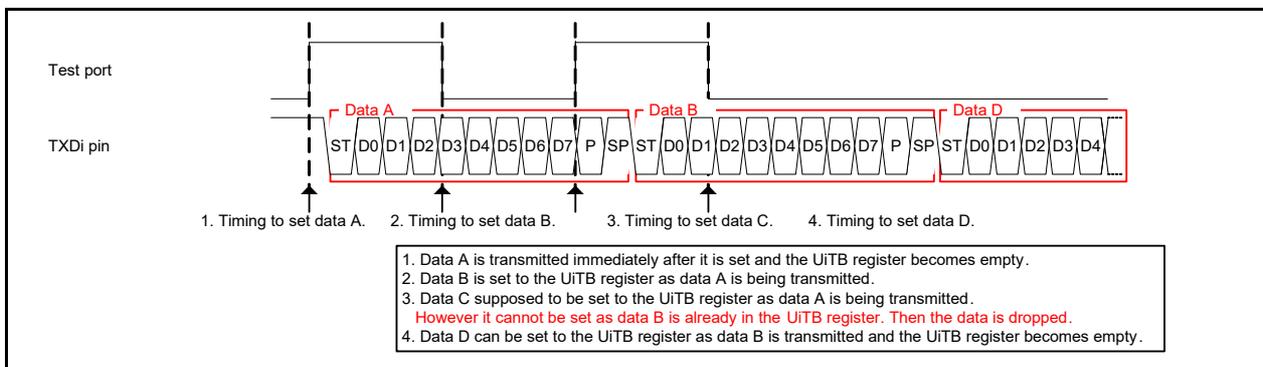
Figure 4.29 Signal pattern in an error operation [C-9]

The test port is inverted multiple times while 1-byte transmit data is output. In this case the next data is set to the UiTB register while the transmit buffer is full (TI bit in the UiC1 register is 0) and a data may be dropped.

Confirm the transmit buffer is empty or the transmission is completed before setting the next transmit data.

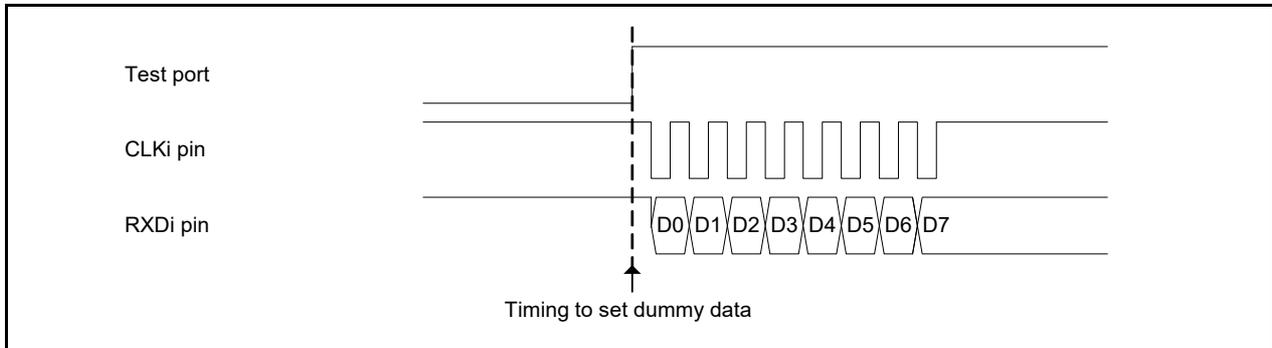
Figure 4.30 Signal pattern in a normal operation [D-1]

The clock is output from the CLKi pin immediately after a signal on the test port is inverted. The receive data is input to the RXDi pin synchronizing with the clock output from the CLKi pin. When the receive data to the RXDi pin is the expected data and the clock is output from the CLKi pin in an expected period, signals on reception are normal. Thus this is not the cause of the issue. Make sure signals satisfy the operating conditions (rated values) in both communication devices.

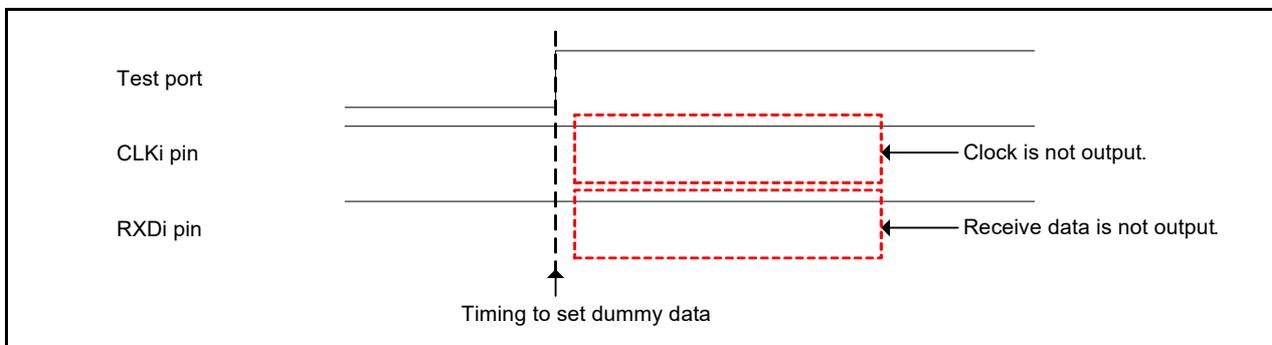
Figure 4.31 Signal pattern in an error operation [D-2]

Signals on pins RXDi and CLKi remain high after a signal on the test port is inverted. In this case the receive condition may not be satisfied. Check whether transmission is enabled (TE bit in the UiC1 register is 1) and the reception is enabled (RE bit in the UiC1 register is 1). Check whether dummy data is set in the UiTB register. Also check whether the CTS function is enabled (bits CRS and CRD in the UiC0 register are 0) though the function is not used. When the CTS function is used, check if the CTSi pin is driven low.

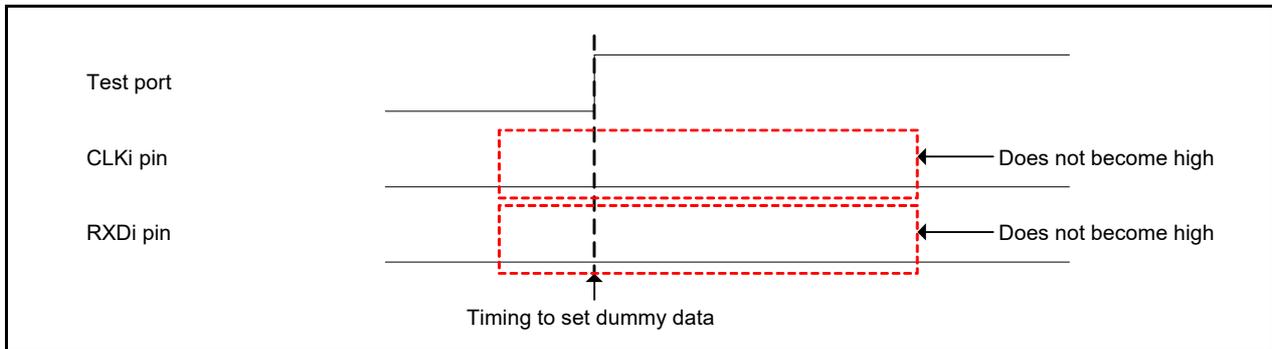
Figure 4.32 Signal pattern in an error operation [D-3]

Signals on pins RXDi and CLKi remain low after a signal on the test port is inverted. In this case the UiMR register may not be specified correctly (the CLKi pin is driven high when clock synchronous serial I/O mode is selected by the UiMR register), the target device may not be ready for communication, or possibly pins RXDi and CLKi are used as N-channel open drain output pins and not pulled up. Specify the UiMR register. Confirm that the target device operates correctly. If pins RXDi and CLKi are used as N-channel open drain output pins, pull them up with an external circuit.

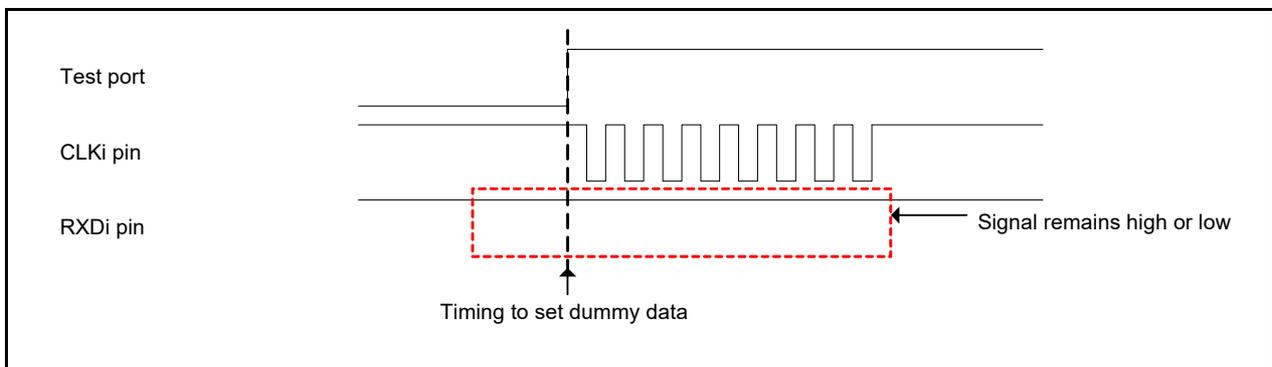
Figure 4.33 Signal pattern in an error operation [D-4]

The RXDi pin does not change the level and remains high or low though the clock is output from the CLKi pin immediately after the test port is inverted. In this case the target device may not be ready for transmission or may not operate correctly. Check whether the start timing of communication or settings on the target device are correct.

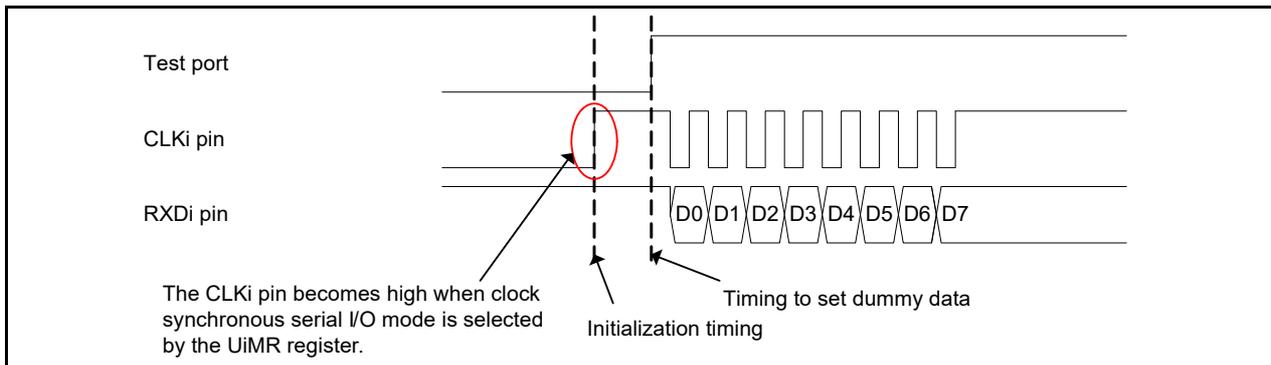
Figure 4.34 Signal pattern in an error operation [D-5]

The CLKi pin is driven low until a certain point. In this case the pin is driven low probably while the serial interface is disabled (until clock synchronous serial I/O mode is selected by the UiMR register). If the CLKi pin changes from low to high, the target device recognizes the change as the transmit/receive clock and bit slippage may occur.

Before the target device becomes ready for communication, set the UiMR register and drive the CLKi pin high, or pull up the CLKi pin with an external circuit, so that the pin level does not change from low to high.

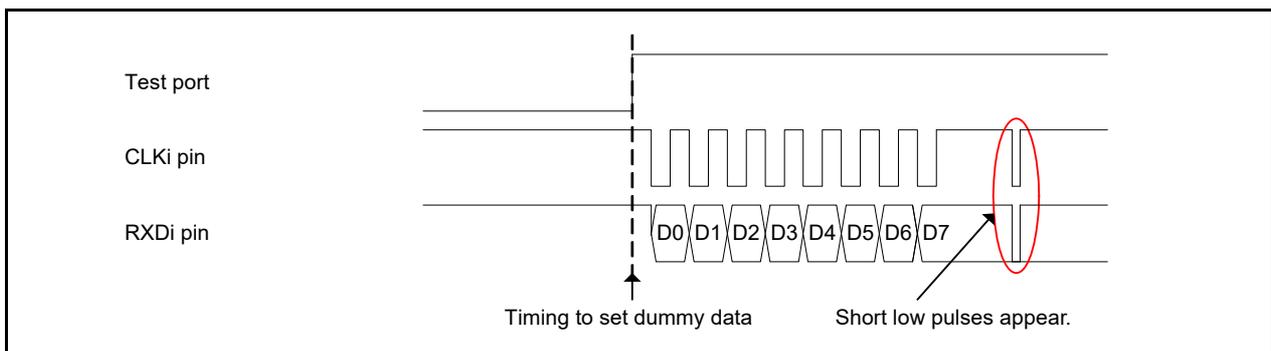
Figure 4.35 Signal pattern in an error operation [D-6]

Do not disable the serial interface every reception. Disable the serial interface when transmission/reception is disabled in the target device or while the CLKi pin is pulled up to avoid bit slippage.

When noise occurs, consider the design with less noise by adding a capacitor or moving the signal lines farther from the cause of the noise.

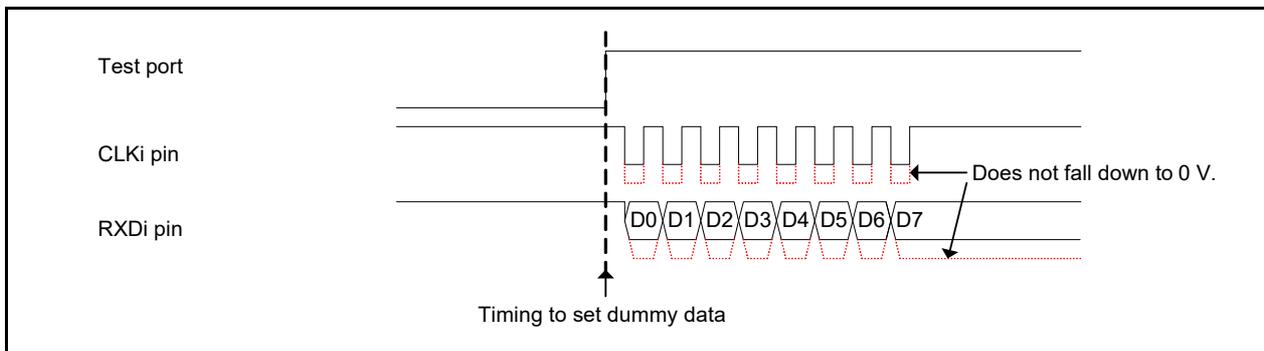
Figure 4.36 Signal pattern in an error operation [D-7]

Low level output from the CLKi pin or input to the RXDi pin does not fall down to 0 V or high level does not rise up to VCC. In this case other pins connected to pins RXDi and CLKi or the target device may output signals and signal collision may occur. Or the operation conditions for VIH or VIL are not satisfied and low and high levels may not be recognized correctly.

Examine the circuit and settings whether signals are output from pins connected to pins RXDi and CLKi or the target device.

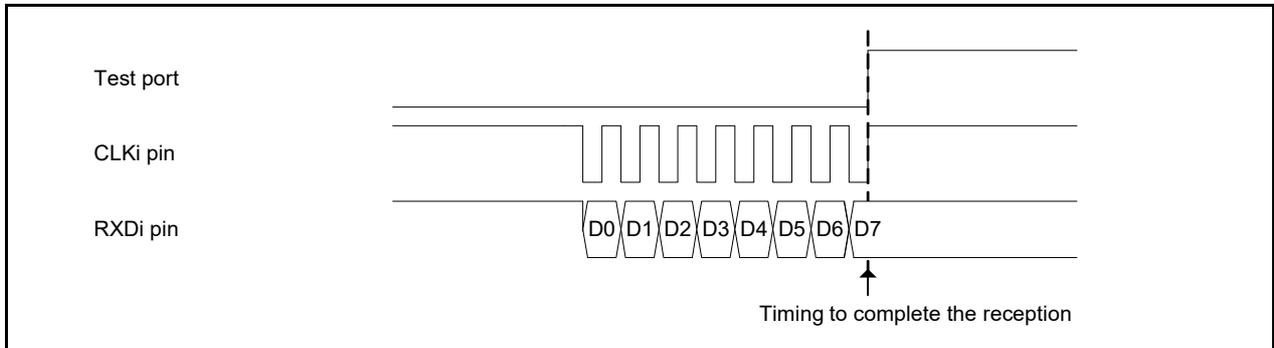
Figure 4.37 Signal pattern in a normal operation [E-1]

A signal on the test port is inverted at the eighth rising timing of the clock input to the CLKi pin. The received data is input to the RXDi pin synchronizing with the clock input to the CLKi pin. In this case the receive data to the RXDi pin is the expected data and the clock is input to the CLKi pin in an expected period. Then input signals can be determined as normal. Thus this is not the cause of the issue. Make sure signals satisfy the operating conditions (rated values) in both communication devices.

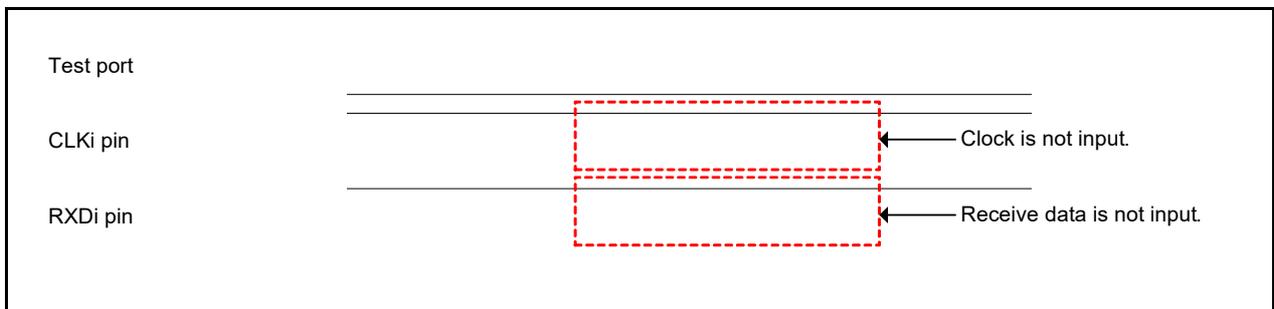
Figure 4.38 Signal pattern in an error operation [E-2]

A signal on the test port is not inverted. Also the receive data and clock are not input to pins RXDi and CLKi, respectively. In this case the target device may not be configured and it may not operate correctly. Check whether the target device is configured correctly.

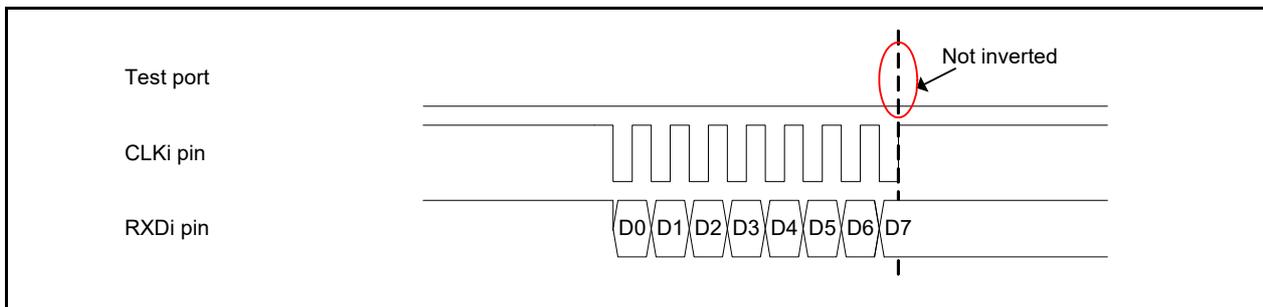
Figure 4.39 Signal pattern in an error operation [E-3]

A signal on the test port is not inverted. The receive data and clock are input to pins RXDi and CLKi, respectively. In this case the condition for the reception may not be satisfied.

Check whether the transmission is enabled (TE bit in the UiC1 register is 1) and the reception is enabled (RE bit in the UiC1 register is 1). Check whether dummy data is set to the UiTB register. Also check whether the CTS function is enabled (bits CRS and CRD in the UiC0 register are 0) though the function is not used. When the CTS function is used, check if the CTSi pin is driven low.

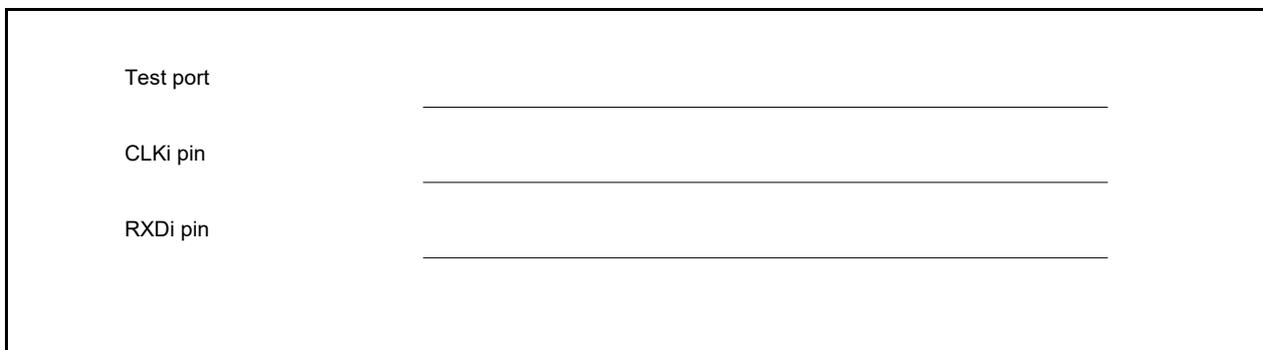
Figure 4.40 Signal pattern in an error operation [E-4]

Signals on the test port, RXDi pin, and CLKi pin do not change and remain low. In this case the target device may not be ready for communication, or pins RXDi and CLKi may be used as the N-channel open drain output pins and not pulled up.

Confirm that the target device operates correctly. If pins RXDi and CLKi are used as the N-channel open drain output pins, pull them up with an external circuit.

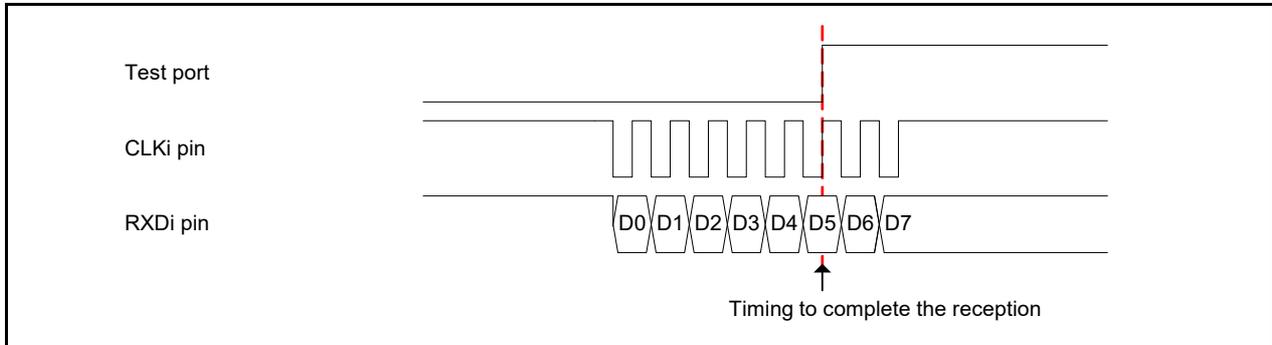
Figure 4.41 Signal pattern in an error operation [E-5]

A signal on the test port is inverted other than at the last (eighth) rising timing of the clock input to the CLKi pin. In this case bit slippage may occur.

Check whether noise occurs on the CLKi pin or the receive condition is met while the CLKi pin is driven low.

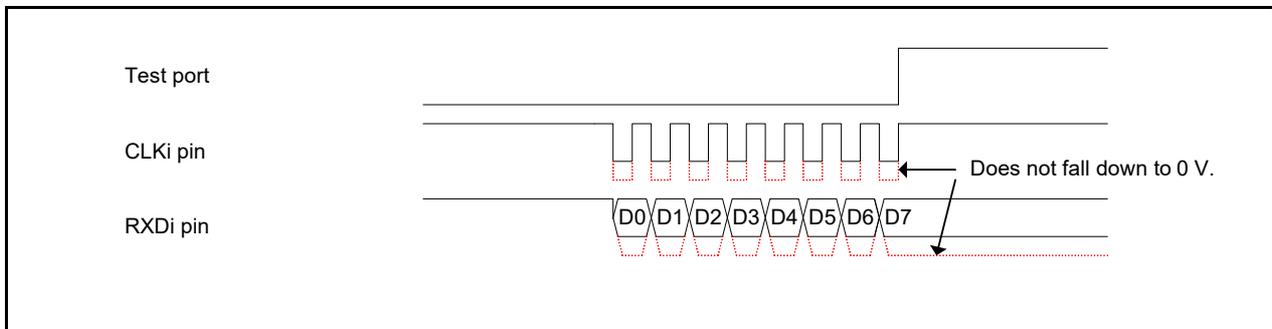
Figure 4.42 Signal pattern in an error operation [E-6]

Low level input to pins CLKi and RXDi does not fall down to 0 V or high level does not rise up to VCC. In this case other pins connected to pins RXDi and CLKi or the target device may output signals and signal collision may occur. Or the operation conditions for VIH or VIL in the M16C MCU may not be satisfied and low and high levels may not be recognized correctly.

Examine the circuit and settings whether signals are output from pins connected to pins RXDi and CLKi or the target device.

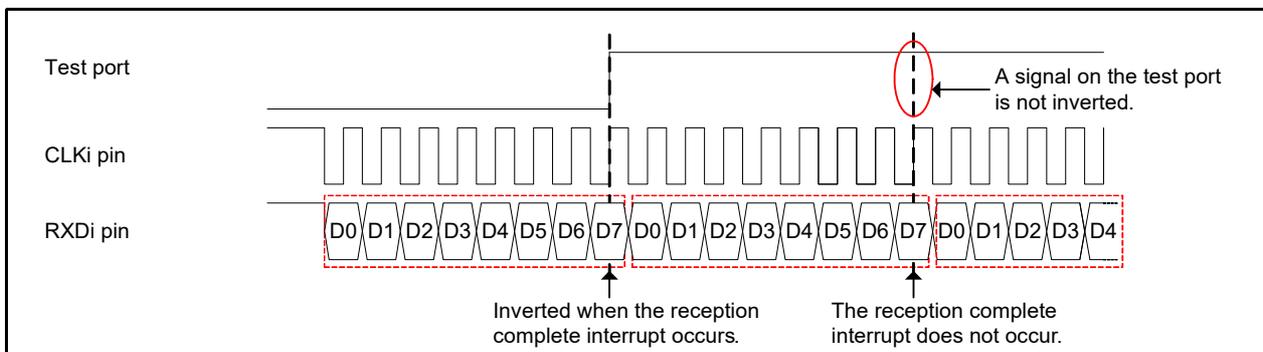
Figure 4.43 Signal pattern in an error operation [E-7]

A signal on the test port is inverted when the first byte reception is completed but not inverted when the second byte reception is completed. In this case the receive buffer may not be read when a reception is completed. If the next data is received before reading the received data, an overrun error occurs. However the receive interrupt request bit does not change, thus an interrupt does not occur. After data reception, read the receive buffer before the next data is received.

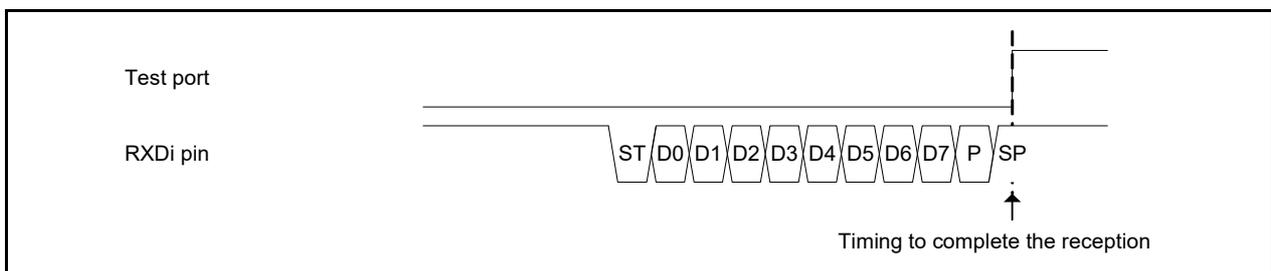
Figure 4.44 Signal pattern in a normal operation [F-1]

When the receive data is input to the RXDi pin in the expected bit rate and the received data is as expected, the input signal is normal. Thus this is not the cause of the issue.

Make sure signals satisfy the operating conditions (rated values) in both communication devices.

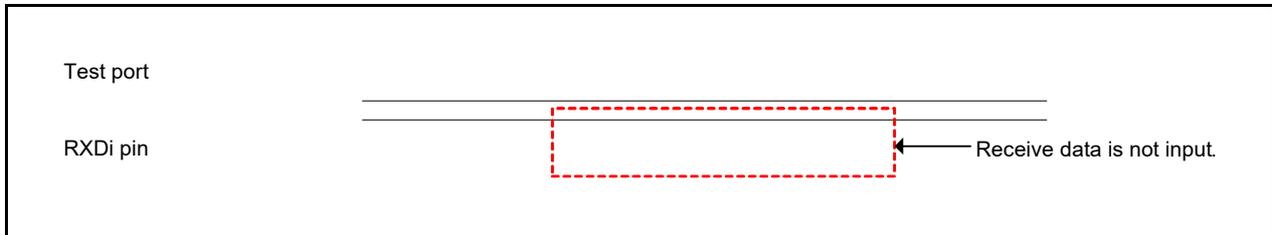
Figure 4.45 Signal pattern in an error operation [F-2]

A signal on the test port is not inverted. Also the receive data is not input to the RXDi pin. In this case the target device may not be configured and it may not operate correctly. Check whether the target device is configured correctly.

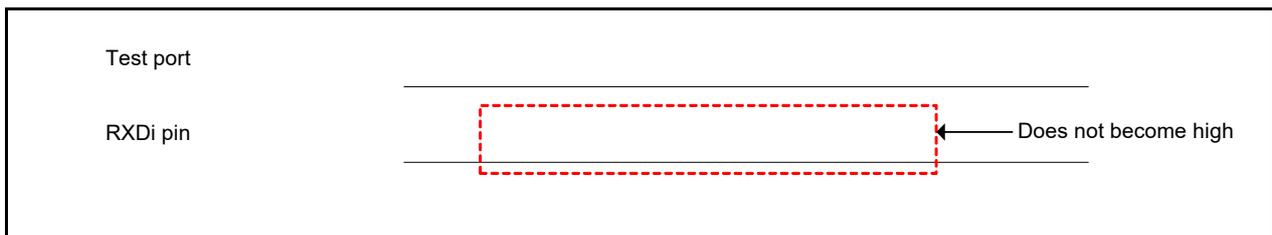
Figure 4.46 Signal pattern in an error operation [F-3]

Signals on the test port and RXDi pin do not change and remain low. In this case the target device may not be ready for communication, or the RXDi pin may be used as the N-channel open drain output pin and not pulled up. Confirm that the target device operates correctly. If the RXDi pin is used as the N-channel open drain output pin, pull it up with an external circuit.
