**M16C/63, 64A, 64C, 65, 65C, 6C, 5LD, 56D, 5L, 56,
5M, and 57 Groups**

R01AN1622EJ0120
 Rev. 1.20
 Dec.15, 2017

Troubleshooting for Serial Communications in Development

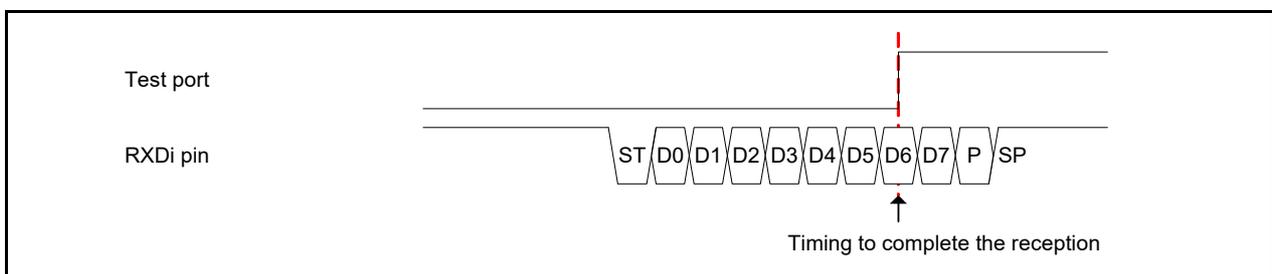
Figure 4.47 Signal pattern in an error operation [F-4]

The test port is inverted during the receive data being input to the RXDi pin. In this case the bit rate in the M16C may differ from the one in the target device. Check whether settings for the UiBRG register, CPU clock, and count source are correctly specified. Also check whether the bit rate in the target device is correct.

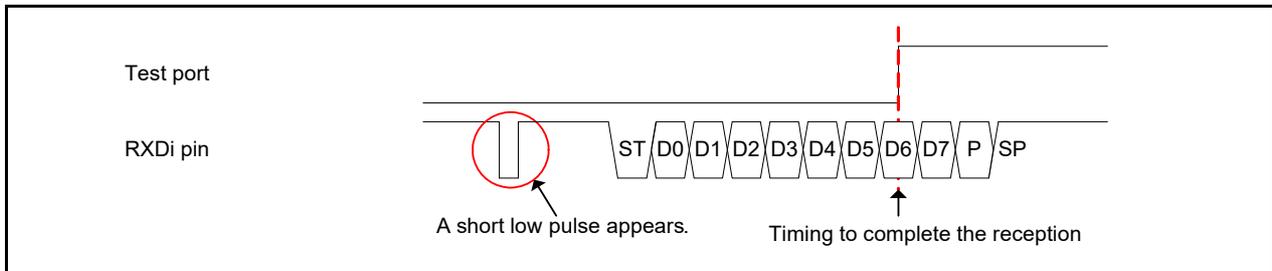
Figure 4.48 Signal pattern in an error operation [F-5]

A short low pulse appears before the receive data is input to the RXDi pin. A signal on the test port is inverted during the receive data being input to the RXDi pin. In this case the short pulse may be recognized as the start bit. Also the low pulse may be noise introduced from peripheral circuits or external sources.

When noise occurs, consider the design with less noise by adding a capacitor or moving the signal lines farther from the cause of the noise.

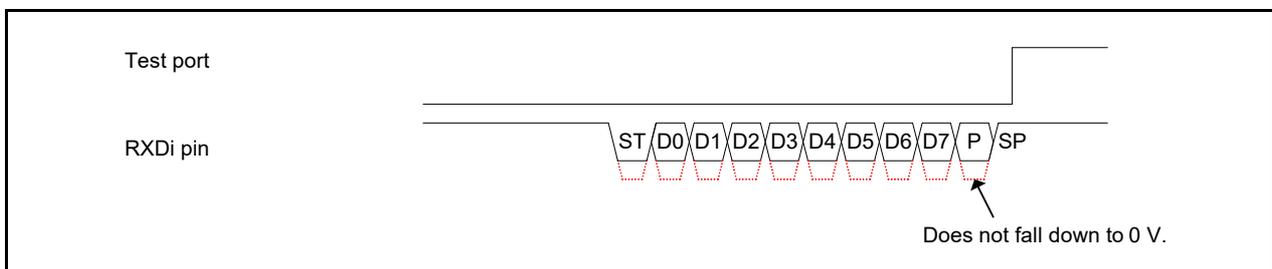
Figure 4.49 Signal pattern in an error operation [F-6]

Low level input to the RXDi pin does not fall down to 0 V or high level does not rise up to VCC. In this case other pins connected to the RXDi pin or the target device may output signals and signal collision may occur. Or the operation conditions for VIH or VIL are not satisfied and low and high levels may not be recognized correctly.

Examine the circuit and settings whether signals are output from pins connected to the RXDi pin or the target device.

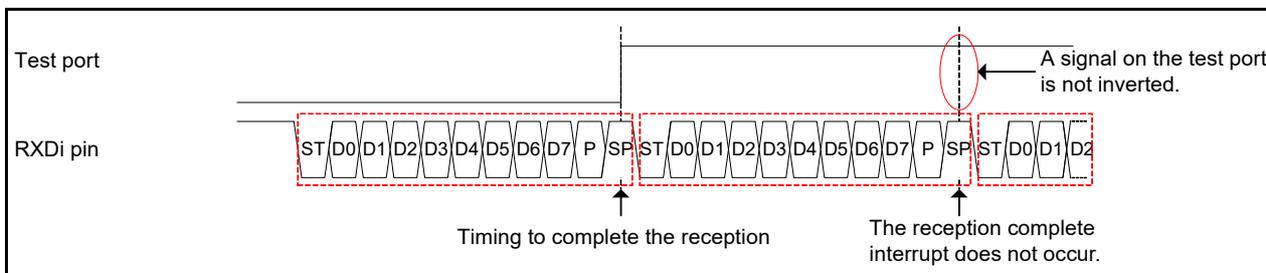
Figure 4.50 Signal pattern in an error operation [F-7]

A signal on the test port is inverted when the first byte reception is completed but not inverted when the second byte reception is completed. In this case the receive buffer may not be read when a reception is completed. If the next data is received before reading the received data, an overrun error occurs. However the receive interrupt request bit does not change, thus an interrupt does not occur. After data reception, read the receive buffer before the next data is received.
