RENESAS TECHNICAL UPDATE

Product Category	MPU/MCU		Document No.	TN-SH7-A717A/E	Rev.	1.00
Title	About R4S76191(SH7619 2ndCut)		Information Category	Product Generation Change		
Applicable Product	All series of SH7619 [R4S7619(0/1)(B/N/D/W)125BG(V)]	Lot No.	Reference Document	SH7619 Group Hardware Manual Rev5.0 (REJ09B0237-0500)		
		All lots

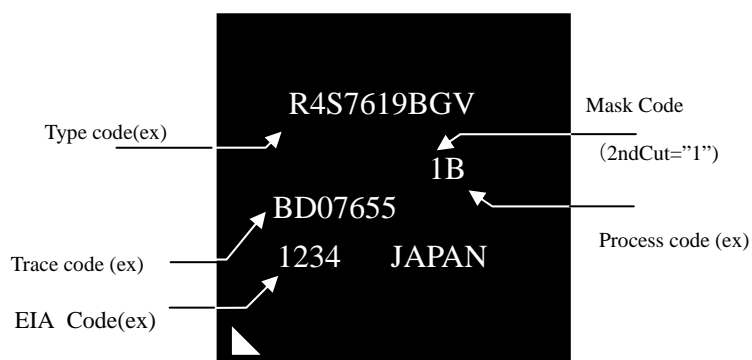
Fig. Mark specification of 2ndCut.

2ndCut	1stCut
Type code	R4S76191*****	R4S76190*****
Mark character	Mask Code=1	No mask code
function	Removing the limitation of a technical update (TN-SH7-A574A/E)	-
Package outline	Same as 1stCut	-

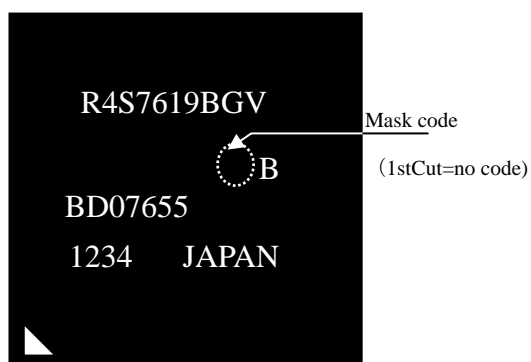
Fig. Mark specification of 1stCut.
