On-chip Debuggers

E2 emulator and E2 emulator Lite (RA Connection)

1. Notes on using E2 emulator or E2 emulator Lite for RA Family

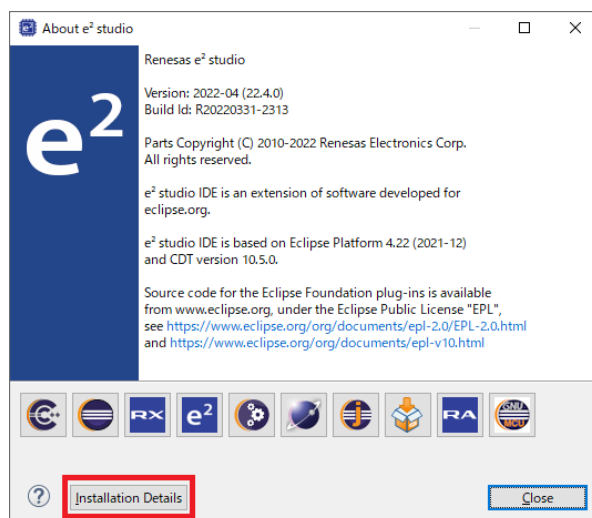
- ⑤ [About e² studio] opens. Click [Installation Details] (framed in red).

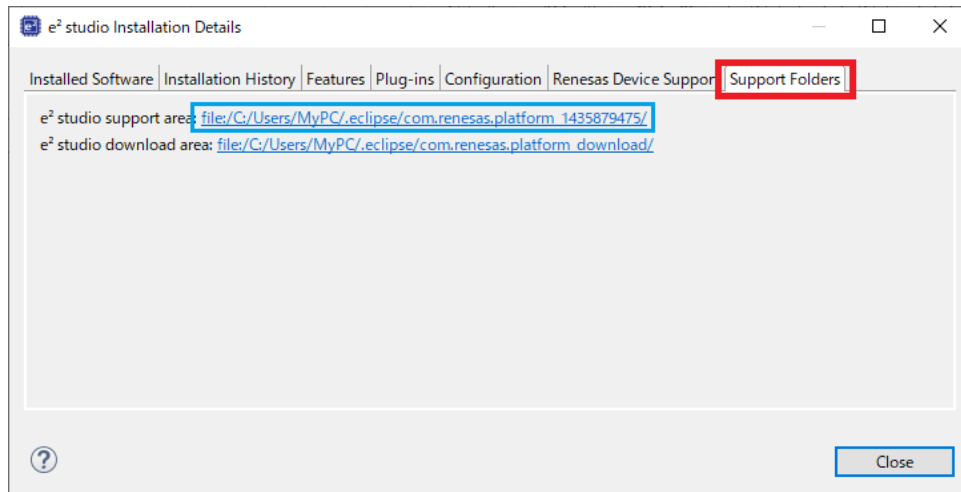
- ⑥ [e² studio Installation Details] opens. Click [Support Folders] (framed in red).
 - ⑦ In [Support Folders], click the link of [e² studio support area] (framed in blue)*.
- *The link in the image is an example. The link varies depending on the user environment.
