PRODUCT/PROCESS CHANGE NOTICE (PCN)

PCN #: N1703-01 Date: May 2, 2017 Product Affected: 8V97053NLGI 8V97053NLGI8 8V97053NLGI/W Date Effective: August 2, 2017	MEANS OF DISTINGUISHING CHANGED DEVICES: <input checked="" type="checkbox"/> Product Mark Prefix character on date code line as shown on Attachment 1 <input type="checkbox"/> Back Mark <input type="checkbox"/> Date Code <input type="checkbox"/> Other
Contact: TSD Clock Team E-mail: clocks@idt.com	Attachment: <input checked="" type="checkbox"/> Yes <input type="checkbox"/> No Samples: Samples are available now.

ATTACHMENT 1 - PCN #: N1703-01

PCN Type: Die Revision Change

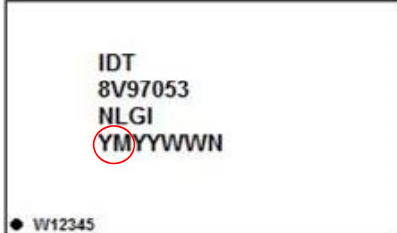
Example of Prefix character change in datecode line

From: YI	To: YM

<p>IDT 8V97053 NLGI YMYWWN</p> <p>● W12345</p>

Detail of Change: The change improves device robustness for low temperature operation. On other similar devices, a circuit marginality may on rare occasions cause the device to power up in an undesirable state in low temperature environments. Pro-active measures to implement the same resolution on this device, which uses a similar circuit, have been taken. The failing power-up condition would potentially be seen at cold temperature as for other similar devices even though none has been observed so far. Possible failure modes related to this potential low temperature fault include: no output switching, switching at an incorrect frequency, no access to the registers, and wrong configuration in the digital PLL blocks. While the probability of this fault being manifest in the current design is low, the above mentioned design change will completely eliminate the possibility of this fault occurring.
