Errata SLG46169 CE-GP-020

This document contains the known errata for SLG46169 and the recommended workarounds.

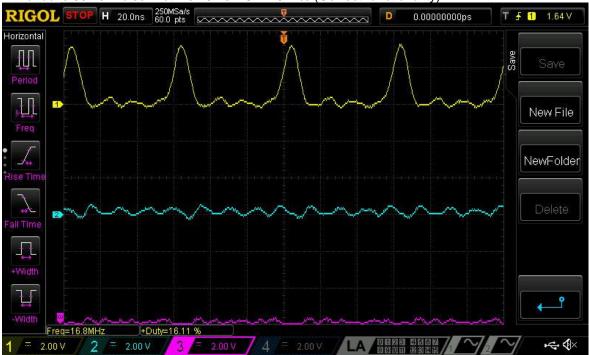
2. Period is 60 ns. Pulse width is 20 ns DC = 33.3 % (Incorrect functionality)

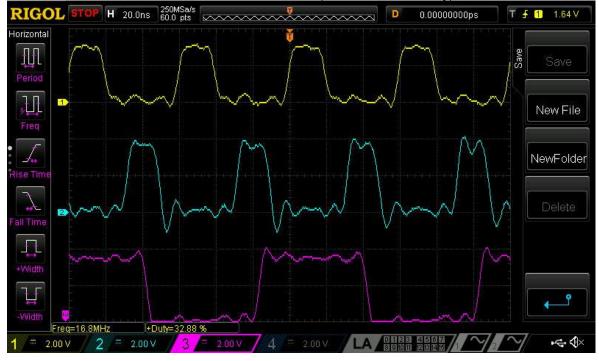
3. Period is 60 ns. Pulse width is 30 ns DC = 50 % (Incorrect functionality)

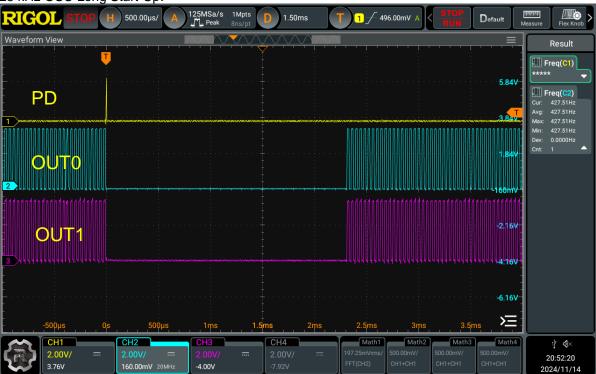
25 kHz OSC Long Start-Up:

If a pulse with a duration of less than \sim 40 ns is applied to the PWR DOWN input of the oscillator, the oscillator outputs remain stuck for milliseconds, as shown in figures below. This issue is observed for both 25 kHz and 2 MHz oscillators.

Change the Fast Start-up setting to "Enable" (see figure below) or avoid applying glitches to the PWR DOWN input of the oscillator.
