## ISL73006SLH

Single Event Effects (SEE) Testing of the ISL73006SLH 18V, 1A Point-of-Load Regulator

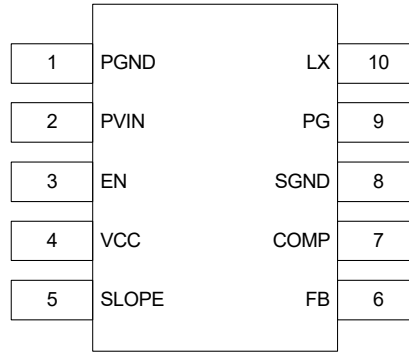
Figure 1. ISL73006SLH Pin Assignments

Pin Number	Pin Name	Description
1	PGND	Power-ground connection. Ground return for the low-side power MOSFET.
2	PVIN	Power Input. Supplies the power switches of the buck converter.
3	EN	Enable input. This input is a comparator-type input with a rising threshold of 1.2V. Bypass this pin to the PCB ground plane with a 10nF ceramic capacitor to mitigate SEE. This pin can be tied to a maximum of 5V.
4	VCC	Linear regulator output from PVIN to provide an internal bias supply rail of up to 5V. Bypass this pin to the PCB ground plane with a 2.2μF ceramic or low ESR Tantalum capacitor for stability, SEE, and noise mitigation. VCC is not intended to bias external circuits.
5	SLOPE	Slope Compensation. Connect a resistor from this pin to GND to externally set the slope compensation. This pin is a current source of 12μA into the external resistor. Connect the SLOPE pin to VCC to use the default internal slope compensation voltage of 1.2V. If not connected to VCC, add a 1nF capacitor from this pin to ground for SEE mitigation.

6	FB	Error Amplifier inverting input. Connect a resistor divider from VOUT to GND with the midpoint driving the FB pin.
7	COMP	Error Amplifier output. The external compensation network is connected from this pin to GND. Tie this pin to VCC to use the internal Error Amplifier compensation setup.
8	SGND	Signal ground. The ground is associated with the internal control circuitry. Connect this pin directly to the PCB ground plane at a single point. Pin 8 is connected to the thermal flash on the package bottom and the lid.
9	PG	Power-good output. The pin is an open-drain logic output pulled to SGND when the output is outside of the PGOOD range. The pin can be pulled to any voltage up to the PVIN absolute maximum limit. Renesas recommends using a nominal 1kΩ to 10kΩ pull-up resistor. Bypass this pin to the PCB ground plane with a 100pF capacitor for SEE mitigation.
10	LX	Switch node connection. Connect this pin to the output filter inductor. Internally, this pin is connected to the common node of the synchronous MOSFET power switches.

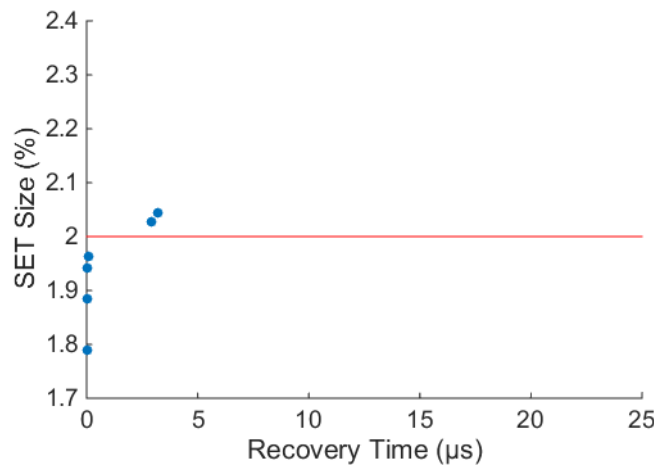
Figure 2 through Figure 4 show scatter plots of the maximum  $V_{OUT}$  deviation in percentage of the nominal  $V_{OUT}$  voltage versus the SET recovery time in microseconds for test conditions #2, #4, and #6, respectively. The recovery time was defined as the duration  $V_{OUT}$  deviated beyond 2% of its nominal value. Some events had maximum  $V_{OUT}$  deviations of less than 2% and were triggered due to noise. The red lines indicate the 2%  $V_{OUT}$  deviation criteria. All the SETs resulted in positive deviations in  $V_{OUT}$ . The maximum SET  $V_{OUT}$  deviation was 2.33%, and only two of the 16 SETs had  $V_{OUT}$  deviations beyond 2.2%. The maximum recovery time was 19.7 $\mu\text{s}$ , and only three of the 16 SETs had recovery times longer than 15 $\mu\text{s}$ .

Figure 2. ISL73006SLH TC #2:  $V_{OUT}$  SET Size vs Recovery Time

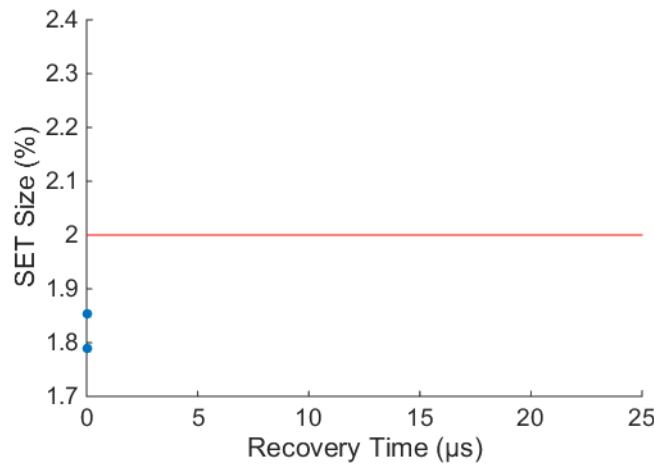
Figure 3. ISL73006SLH TC #4: V<sub>OUT</sub> SET Size vs Recovery Time<sup>[1]</sup>

1. An event at (44.13μs, 2.71%) was a deviation in V<sub>OUT</sub> caused by two ion strikes. Therefore, it is not a single event transient and was omitted from the plot.

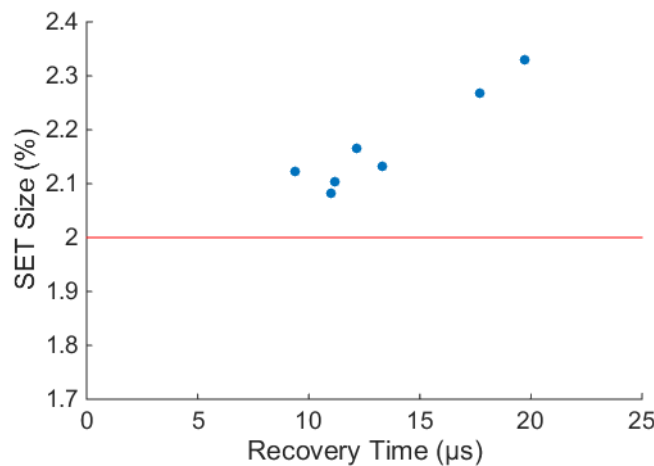
Figure 4. ISL73006SLH TC #6: V<sub>OUT</sub> SET Size vs Recovery Time

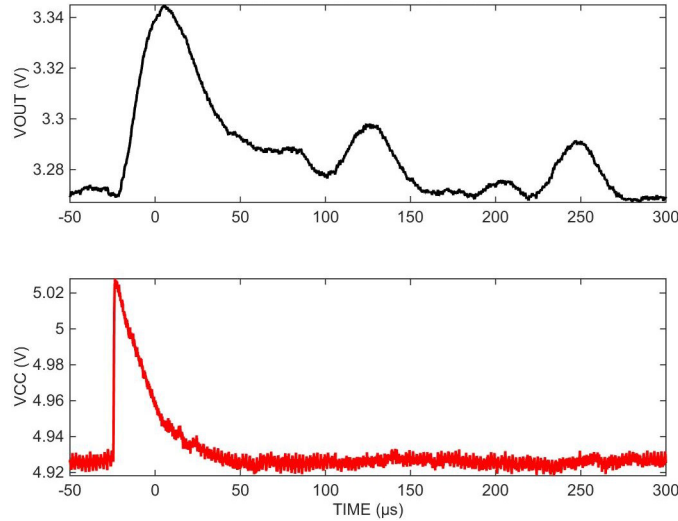
Figure 5 shows the largest SET captured after applying a Gaussian filter by convolving the signal, sampled at a rate of one sample per 10ns, with an 11-point Gaussian window, with a width factor of 2.5. This SET occurred while the device was in TC #6; it had a V<sub>OUT</sub> deviation of 2.33% and a recovery time of 19.7μs. During all of the SETs, there was a sharp increase in VCC (red) by approximately 0.1V. VCC recovered after 80μs. Judging by the timing of the events, it seems that the perturbation in VCC rippled into V<sub>OUT</sub> (black), which peaked at a voltage more than 2% above its nominal voltage. V<sub>OUT</sub> then recovered and returned to its nominal voltage. All 16 SETs had waveforms similar to Figure 5.

Figure 5. Typical SET Capture

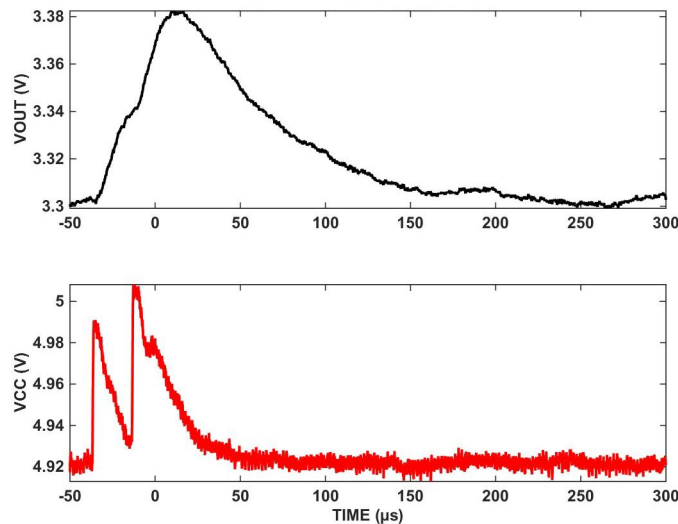
TC #8 and TC#4 had events caused by double ion strikes. Both waveforms are similar to Figure 6. A Gaussian filter was applied to the waveforms in Figure 6 by convolving the signal, sampled at a rate of one sample per 10ns, with an 11-point Gaussian window with a width factor of 2.5. During the event, two distinct impulses on VCC (red) indicated two ion strikes. Each impulse increased  $V_{OUT}$  (black), leading to a larger  $V_{OUT}$  deviation and recovery time. Since these events involved multiple ion strikes, they were not single event transients. Double ion strike events are possible during SEE testing because the flux during SEE testing is much higher than typical fluxes encountered in space. Testing was performed with a flux of  $5E4$ ions/cm<sup>2</sup>/s, which means, on average, five ions will strike every square centimeter of the device every 100μs. Therefore, multiple ions can strike the sensitive area of the device in close temporal proximity. However, this situation is virtually impossible in an ordinary space environment.

Figure 6.  $V_{OUT}$  Deviation from Multiple Ion Strikes

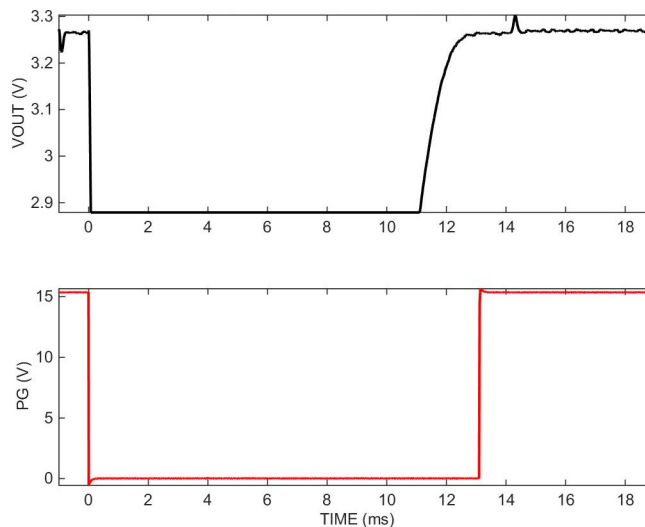
A typical SEFI waveform is shown in [Figure 7](#). PG (red) indicates that the SEFI was approximately 13ms in duration. During the SEFI, V<sub>OUT</sub> (black) fell after PG pulled low. V<sub>OUT</sub> remained low while the device turned on again in a hiccup mode. After approximately 11ms, V<sub>OUT</sub> underwent a spontaneous and full soft start, and it fully recovered around 13ms after the inception of the SEFI, coinciding with PG's recovery. The small spike in V<sub>OUT</sub> at 15ms was a transient caused by the load current switching from 1.1A to 0A. All 44 SEFIs had waveforms similar to [Figure 7](#).

**Figure 7. Typical SEFI Capture**
