R20TS0882EJ0100

Renesas Starter Kit+ for RZ/T2M

Packet Loss during Ethernet or EtherCAT Communication

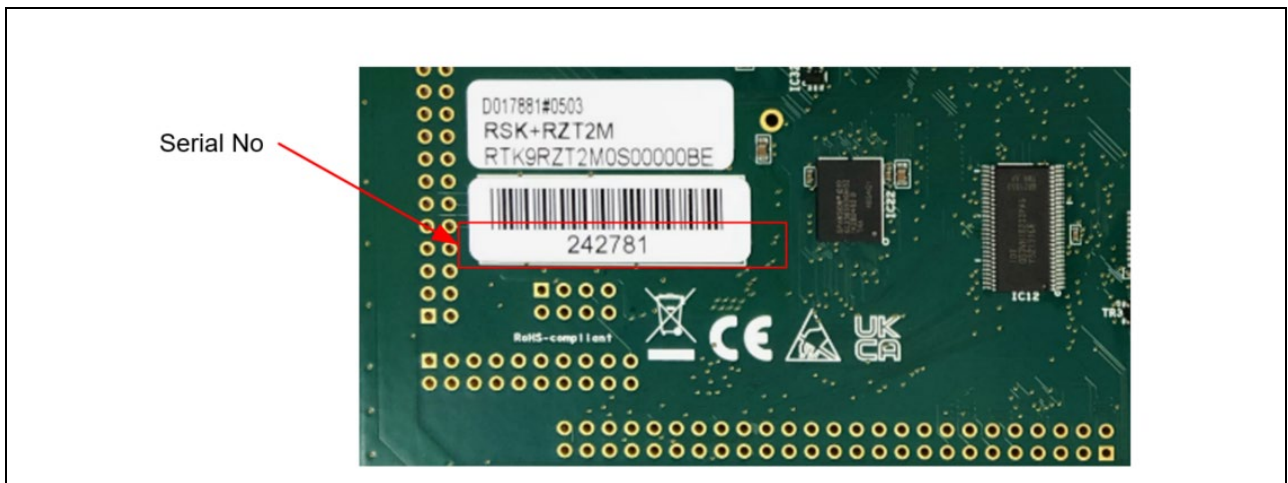
Figure 1: Serial No. location (CPU board solder side)

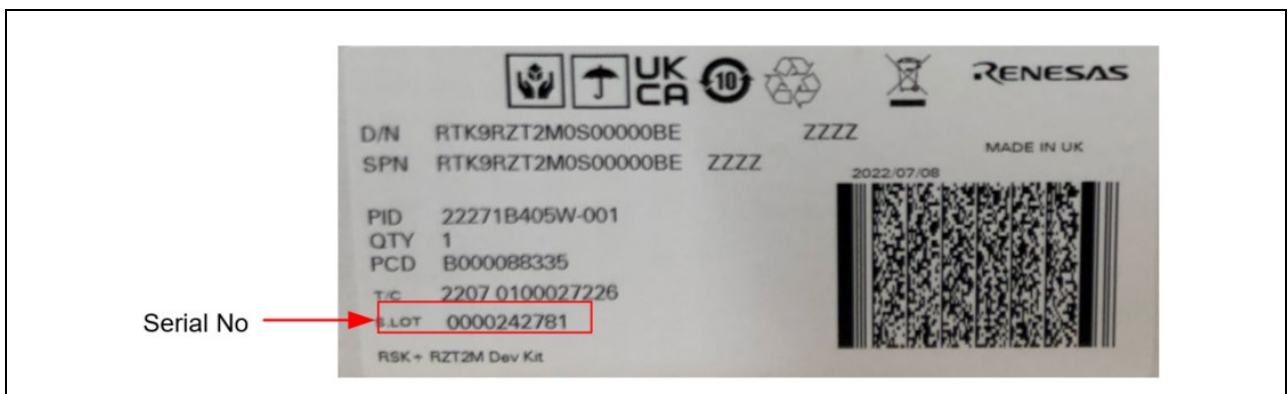
Figure 2: Serial No. location (side of the product box)
