Renesas RA Family

EK-RA6M1

2.1.1 LED2 (Power and debug status) installed incorrectly

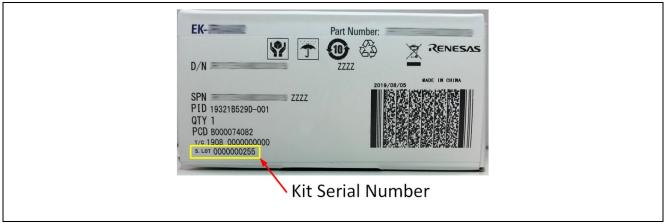
The kit serial number is printed on the outside of the kit packaging. Locate the barcode label on the end of the box. The serial number is identified with the text "S. LOT xxxxxxxxx" found at the bottom of the label as shown in Figure 3.
