PRODUCT/PROCESS CHANGE NOTICE (PCN)

PCN #: N1703-01 Date: May 2, 2017 Product Affected: 8V97053NLGI 8V97053NLGI8 8V97053NLGI/W Date Effective: August 2, 2017	MEANS OF DISTINGUISHING CHANGED DEVICES: <input checked="" type="checkbox"/> Product Mark Prefix character on date code line as shown on Attachment 1 <input type="checkbox"/> Back Mark <input type="checkbox"/> Date Code <input type="checkbox"/> Other
Contact: TSD Clock Team E-mail: clocks@idt.com	Attachment: <input checked="" type="checkbox"/> Yes <input type="checkbox"/> No Samples: Samples are available now.

ATTACHMENT 1 - PCN #: N1703-01

PCN Type: Die Revision Change

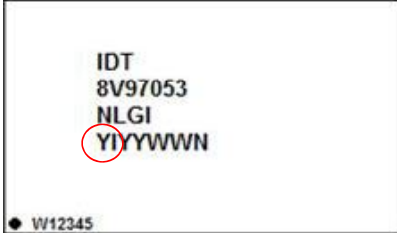
Example of Prefix character change in datecode line

From: YI	To: YM

<p>IDT 8V97053 NLGI YIYYWWN</p> <p>● W12345</p>

Detail of Change: The change improves device robustness for low temperature operation. On other similar devices, a circuit marginality may on rare occasions cause the device to power up in an undesirable state in low temperature environments. Pro-active measures to implement the same resolution on this device, which uses a similar circuit, have been taken. The failing power-up condition would potentially be seen at cold temperature as for other similar devices even though none has been observed so far. Possible failure modes related to this potential low temperature fault include: no output switching, switching at an incorrect frequency, no access to the registers, and wrong configuration in the digital PLL blocks. While the probability of this fault being manifest in the current design is low, the above mentioned design change will completely eliminate the possibility of this fault occurring.
